ELCHO SCHOOL DISTRICT
Facility Planning Study

SDS PROJECT NO.: 1508
AUGUST 2015

Elcho School District K-12 Building

Site Analysis

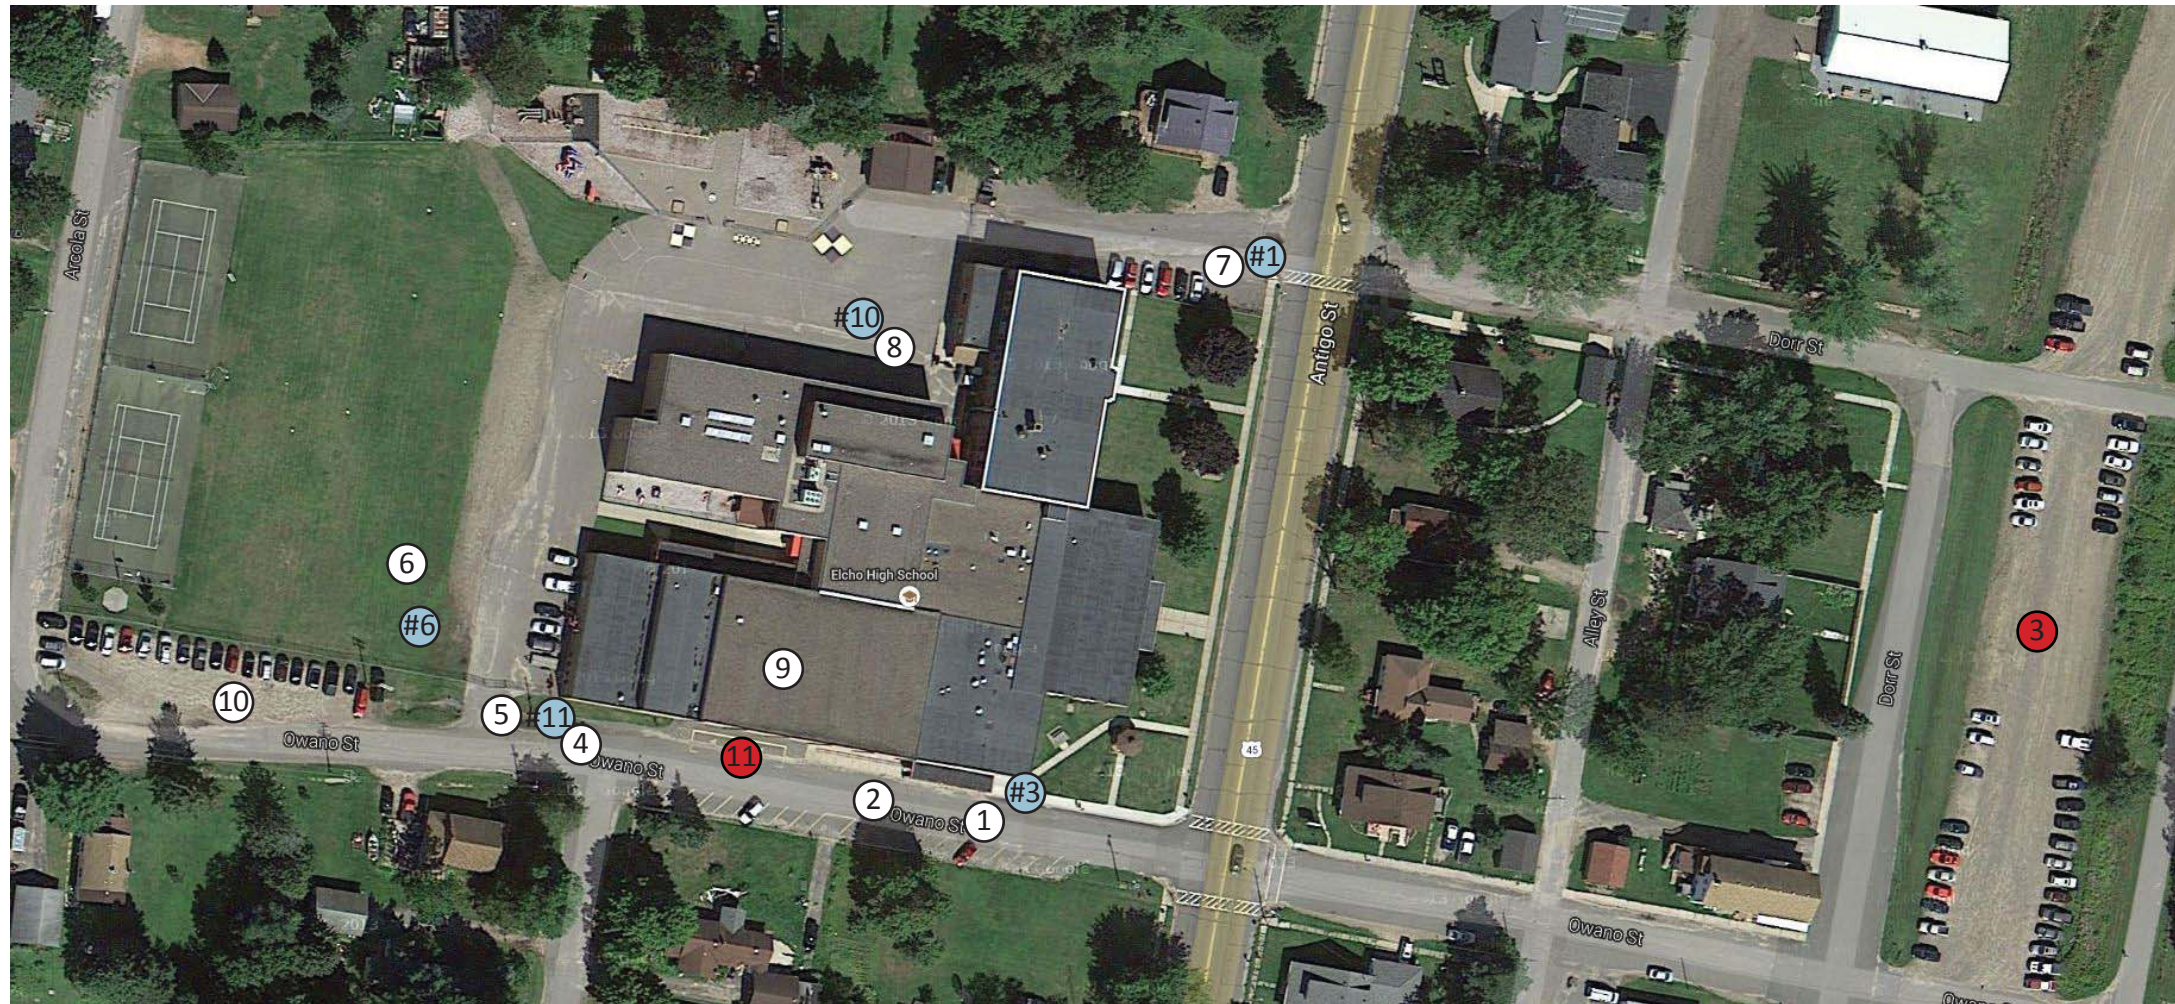
- ① Parking for office/visitors along city street
- ② Congested main entrance for parent pick-up and drop-off
- ③ Main student parking is remotely located
- ④ Roof drainage system to site is inadequate
- ⑤ Broken steel culverts pipe at driveway
- ⑥ Poor site drainage causing standing water
- ⑦ Pavement is cracked and uneven
- ⑧ Water flows back toward the building
- ⑨ Roof drain downspout deposits water into adjacent exit area
- ⑩ Unstriped parking area
- ⑪ No ADA parking stalls located near the main entrance

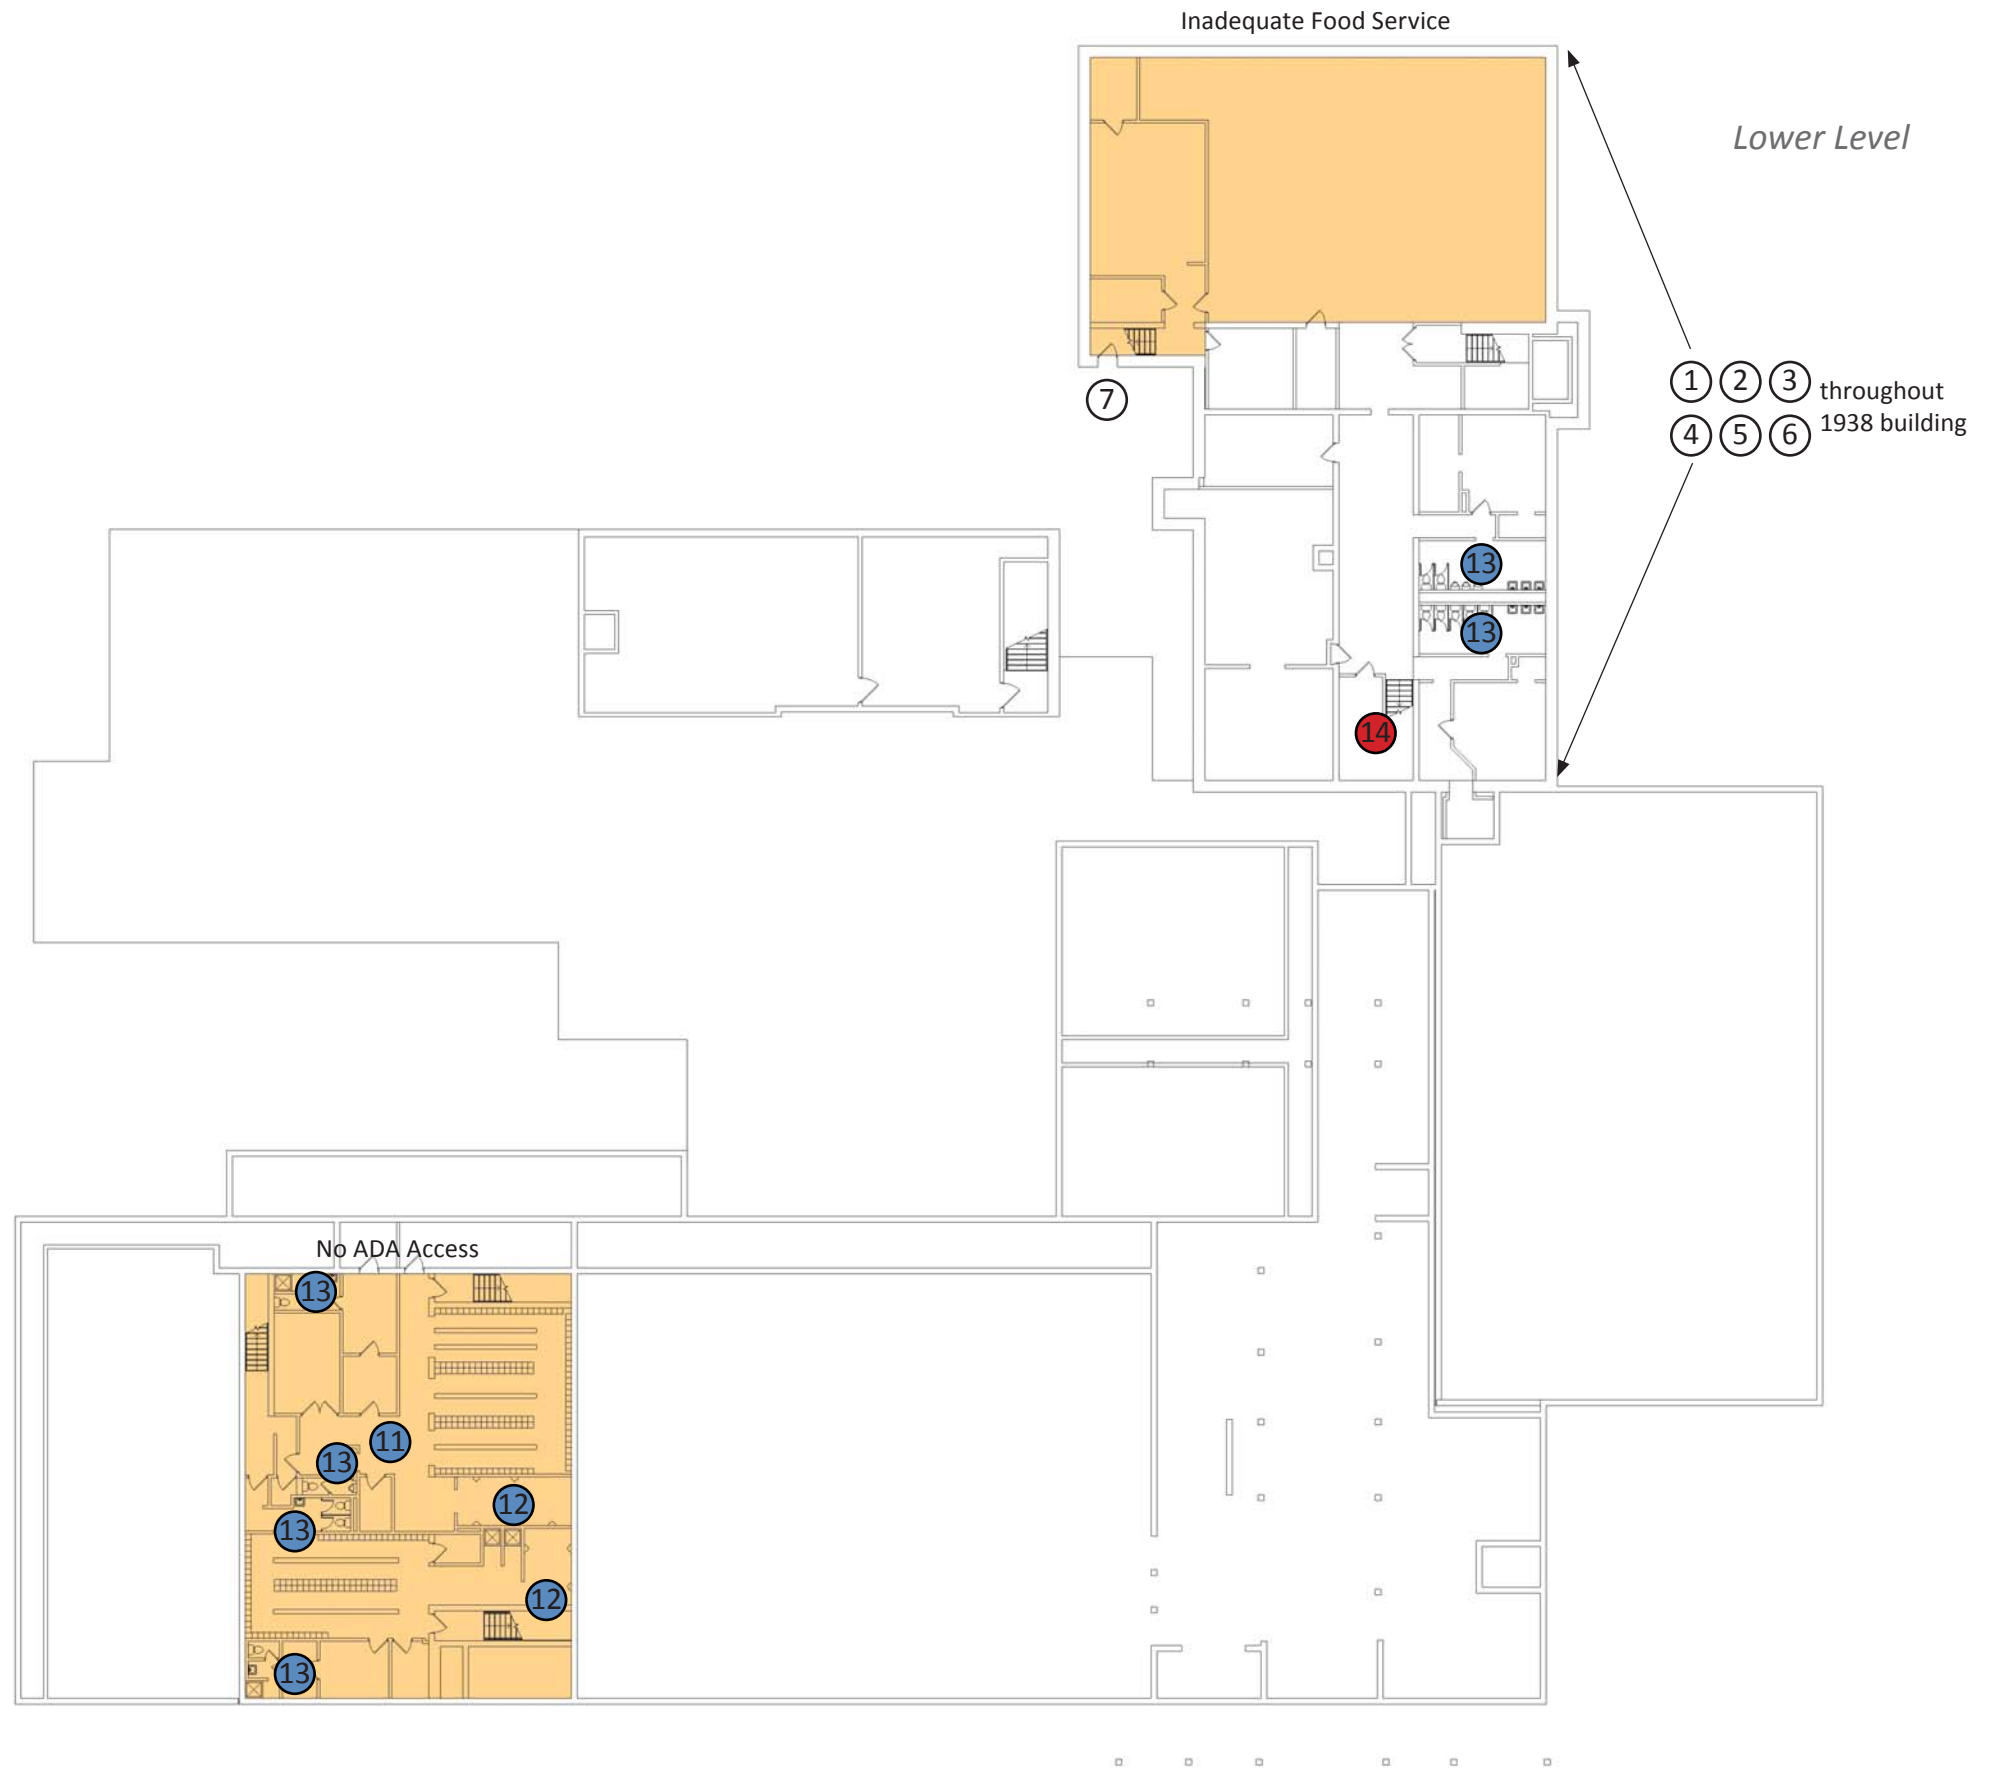
Floor Plan Analysis

- ① Damaged/worn flooring
- ② Damaged/worn cabinets/casework
- ③ Damaged/worn ceiling
- ④ Damaged/worn plumbing fixtures
- ⑤ Inefficient/improper use of space
- ⑥ Damaged/worn door/hardware
- ⑦ Food service deliveries must go down stairs
- ⑧ Temporary wall partition does not provide adequate sound insulation between adjacent spaces
- ⑨ Door hardware is not secure
- ⑩ No visual control of the main entry
- ⑪ No accessible path of travel to main floor
- ⑫ Showers are not ADA compliant
- ⑬ Restroom is not ADA compliant
- ⑭ Stairs do not comply with current building code
- ⑮ Ramp does not comply with current building code

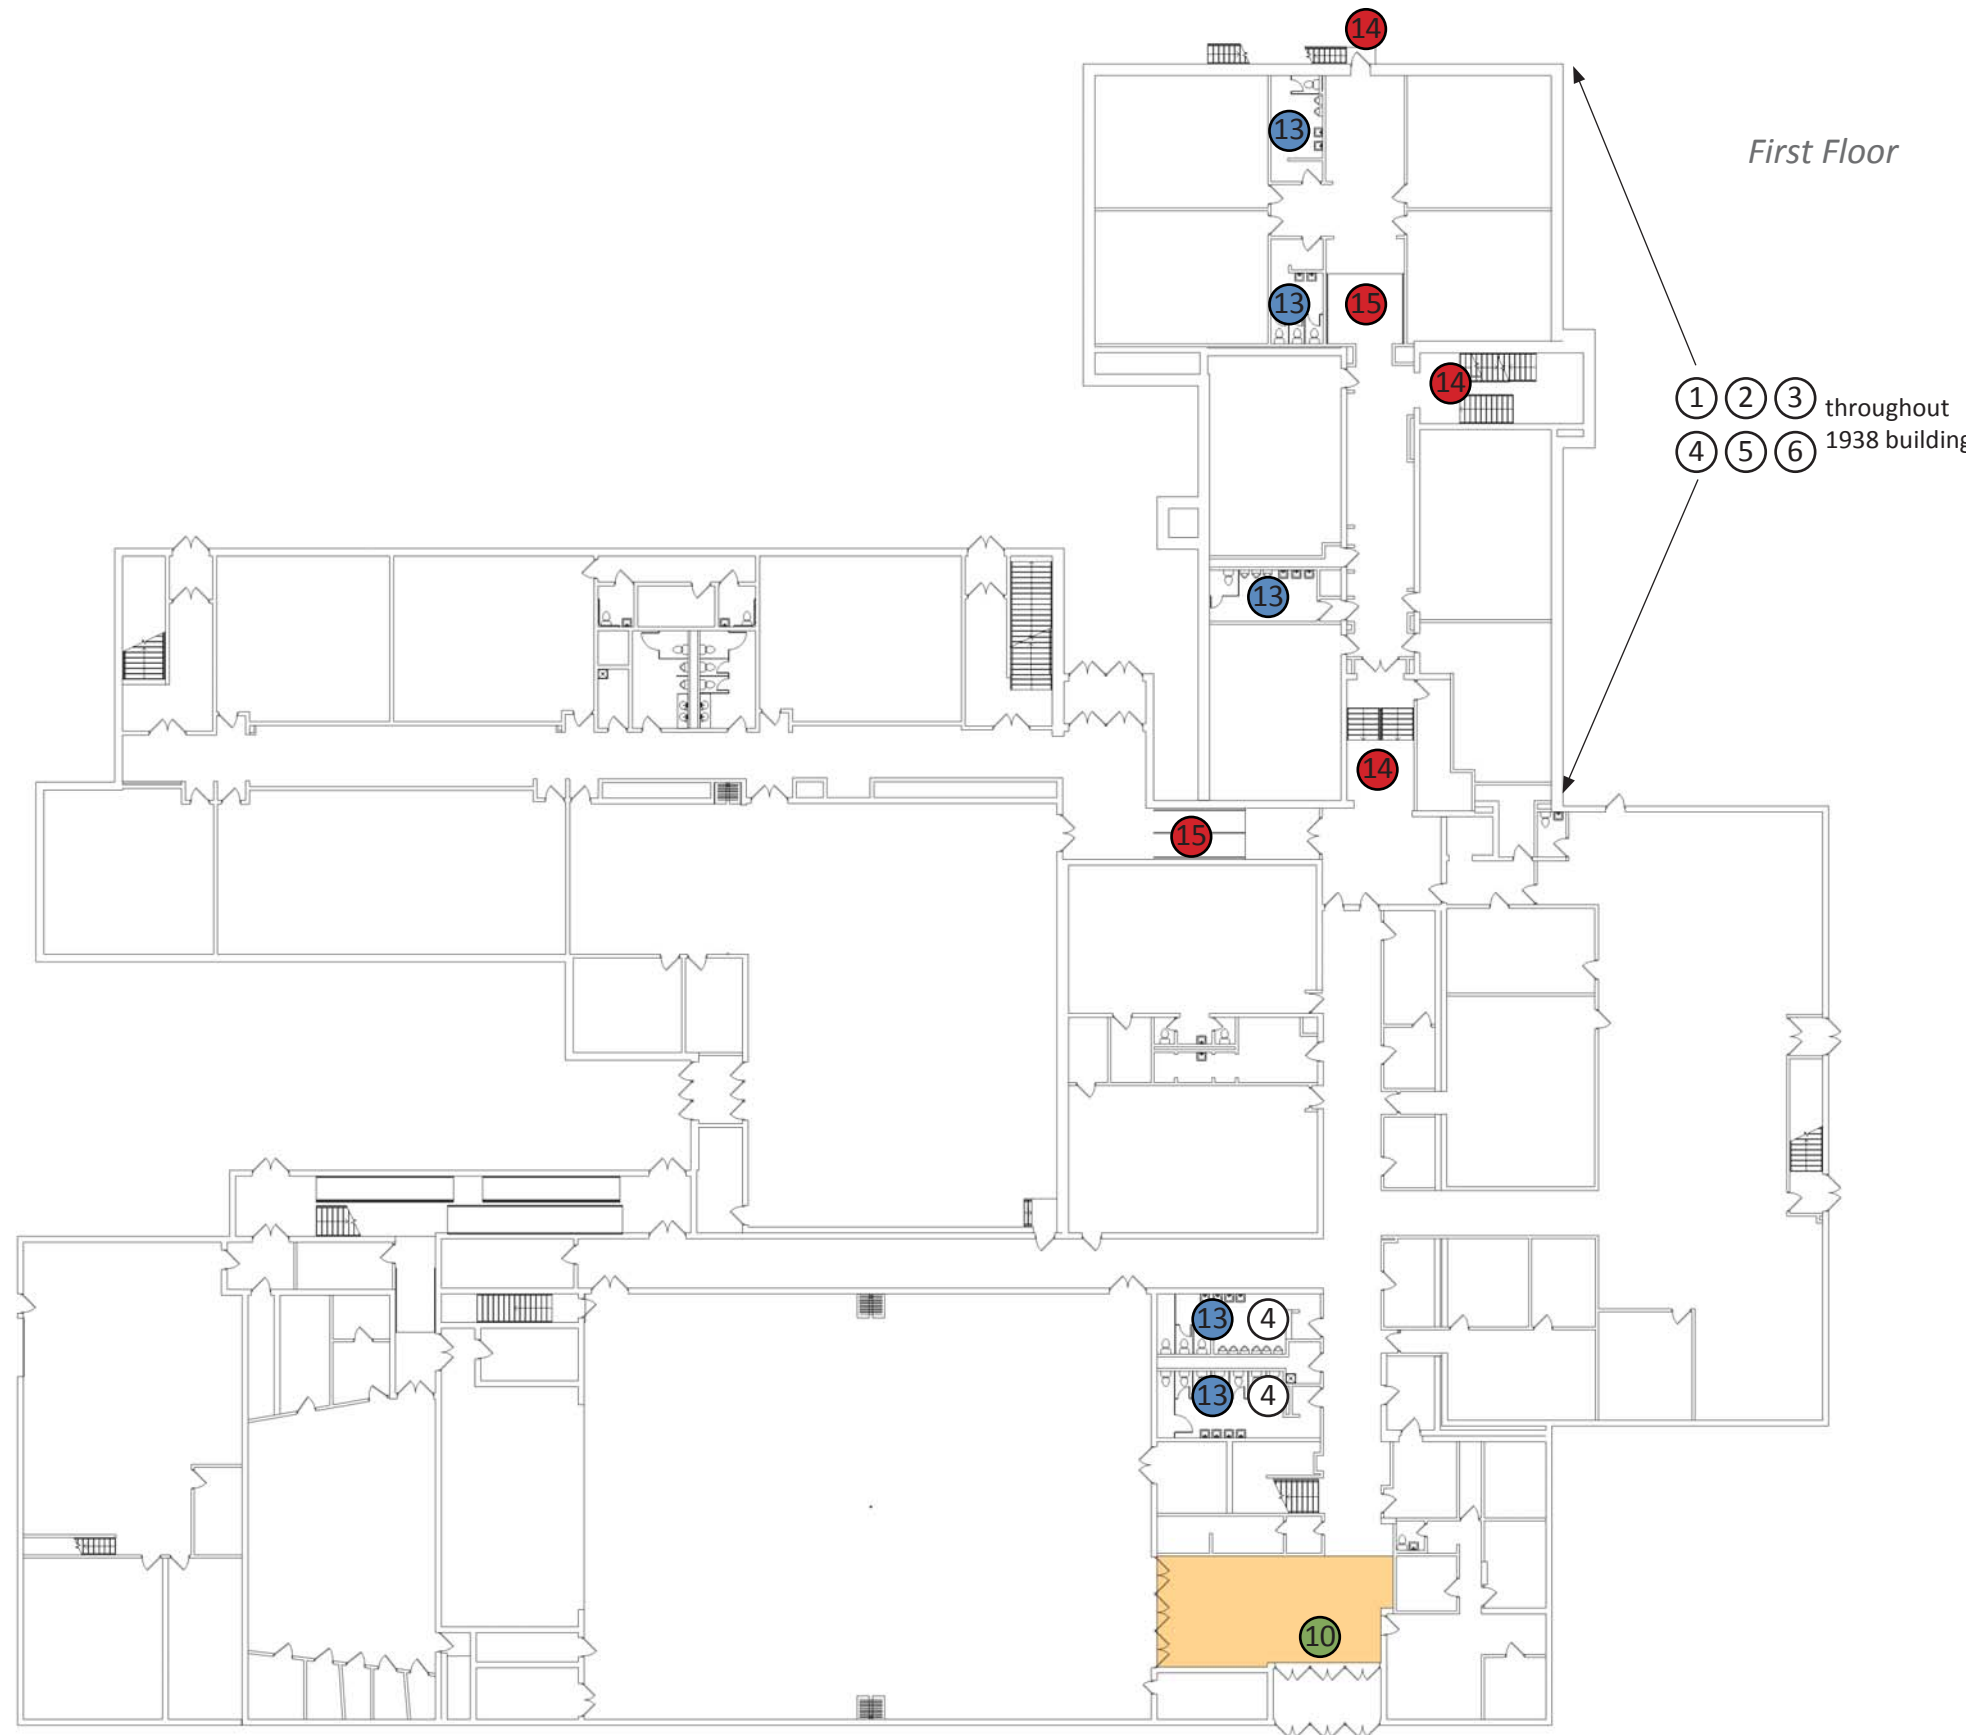
Floor Plan Analysis

- ① Damaged/worn flooring
- ② Damaged/worn cabinets/casework
- ③ Damaged/worn ceiling
- ④ Damaged/worn plumbing fixtures
- ⑤ Inefficient/improper use of space
- ⑥ Damaged/worn door/hardware
- ⑦ Food service deliveries must go down stairs
- ⑧ Temporary wall partition does not provide adequate sound insulation between adjacent spaces
- ⑨ Door hardware is not secure
- ⑩ No visual control of the main entry
- ⑪ No accessible path of travel to main floor
- ⑫ Showers are not ADA compliant
- ⑬ Restroom is not ADA complaint
- ⑭ Stairs do not comply with current building code
- ⑮ Ramp does not comply with current building code

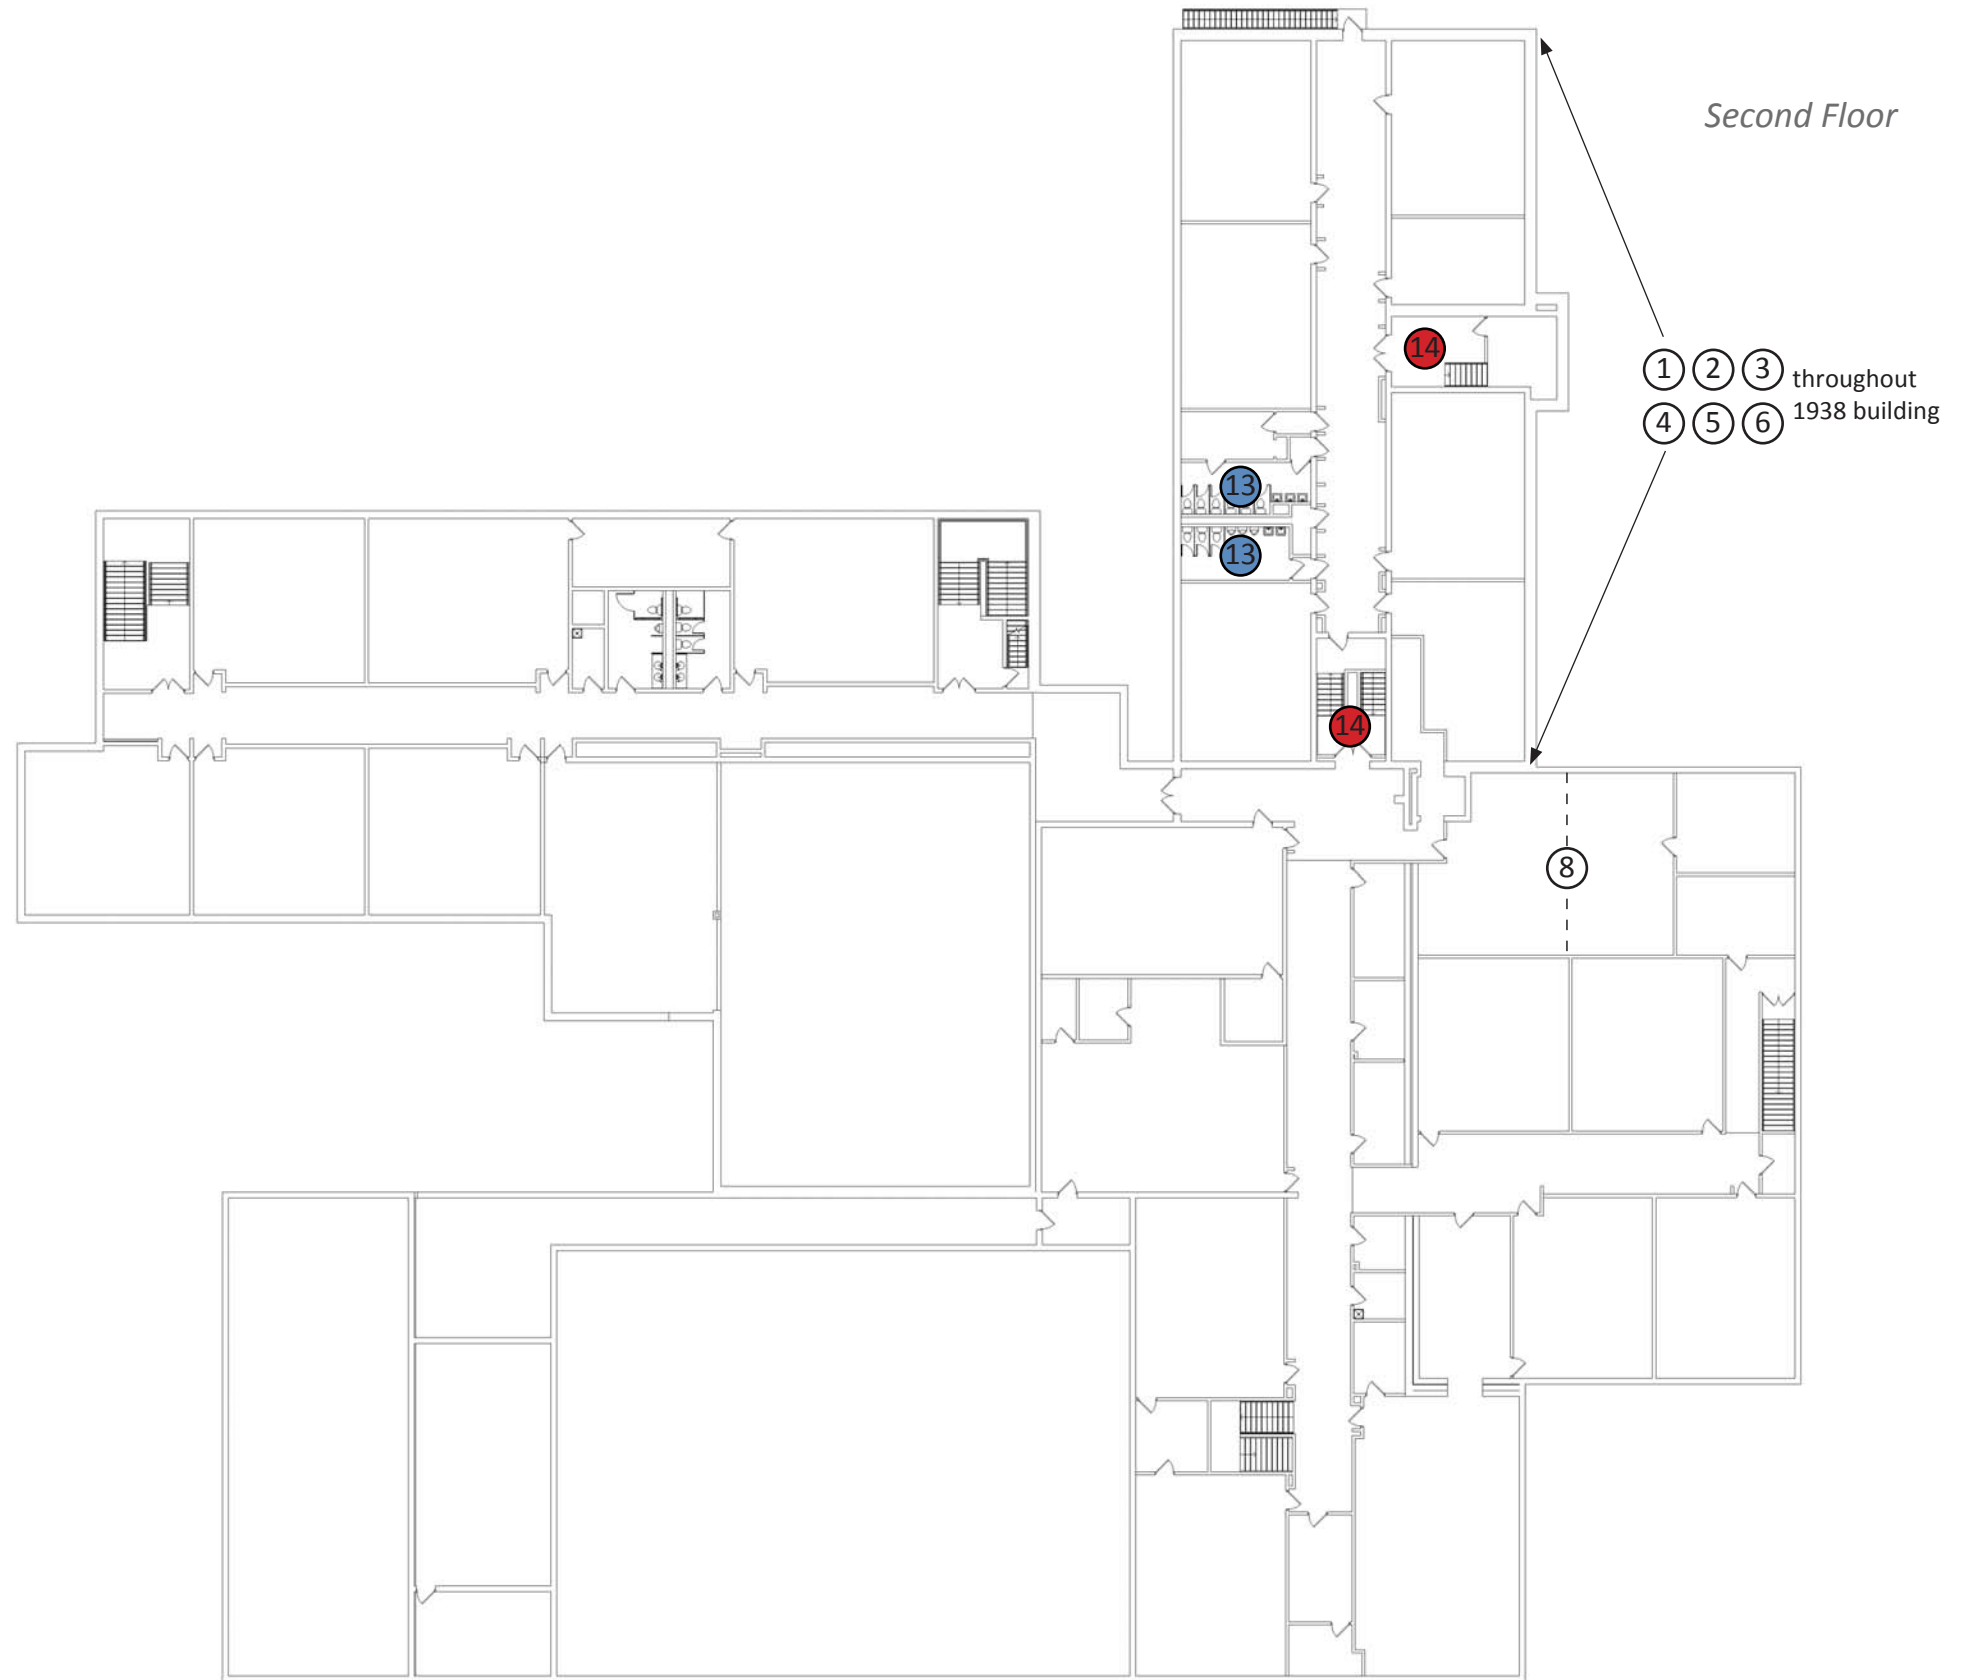
Floor Plan Analysis

- ① Damaged/worn flooring
- ② Damaged/worn cabinets/casework
- ③ Damaged/worn ceiling
- ④ Damaged/worn plumbing fixtures
- ⑤ Inefficient/improper use of space
- ⑥ Damaged/worn door/hardware
- ⑦ Food service deliveries must go down stairs
- ⑧ Temporary wall partition does not provide adequate sound insulation between adjacent spaces
- ⑨ Door hardware is not secure
- ⑩ No visual control of the main entry
- ⑪ No accessible path of travel to main floor
- ⑫ Showers are not ADA compliant
- ⑬ Restroom is not ADA complaint
- ⑭ Stairs do not comply with current building code
- ⑮ Ramp does not comply with current building code
